Atmospheric River: Rain, Flooding and Slope Failures

British Columbia and Washington, November 2021

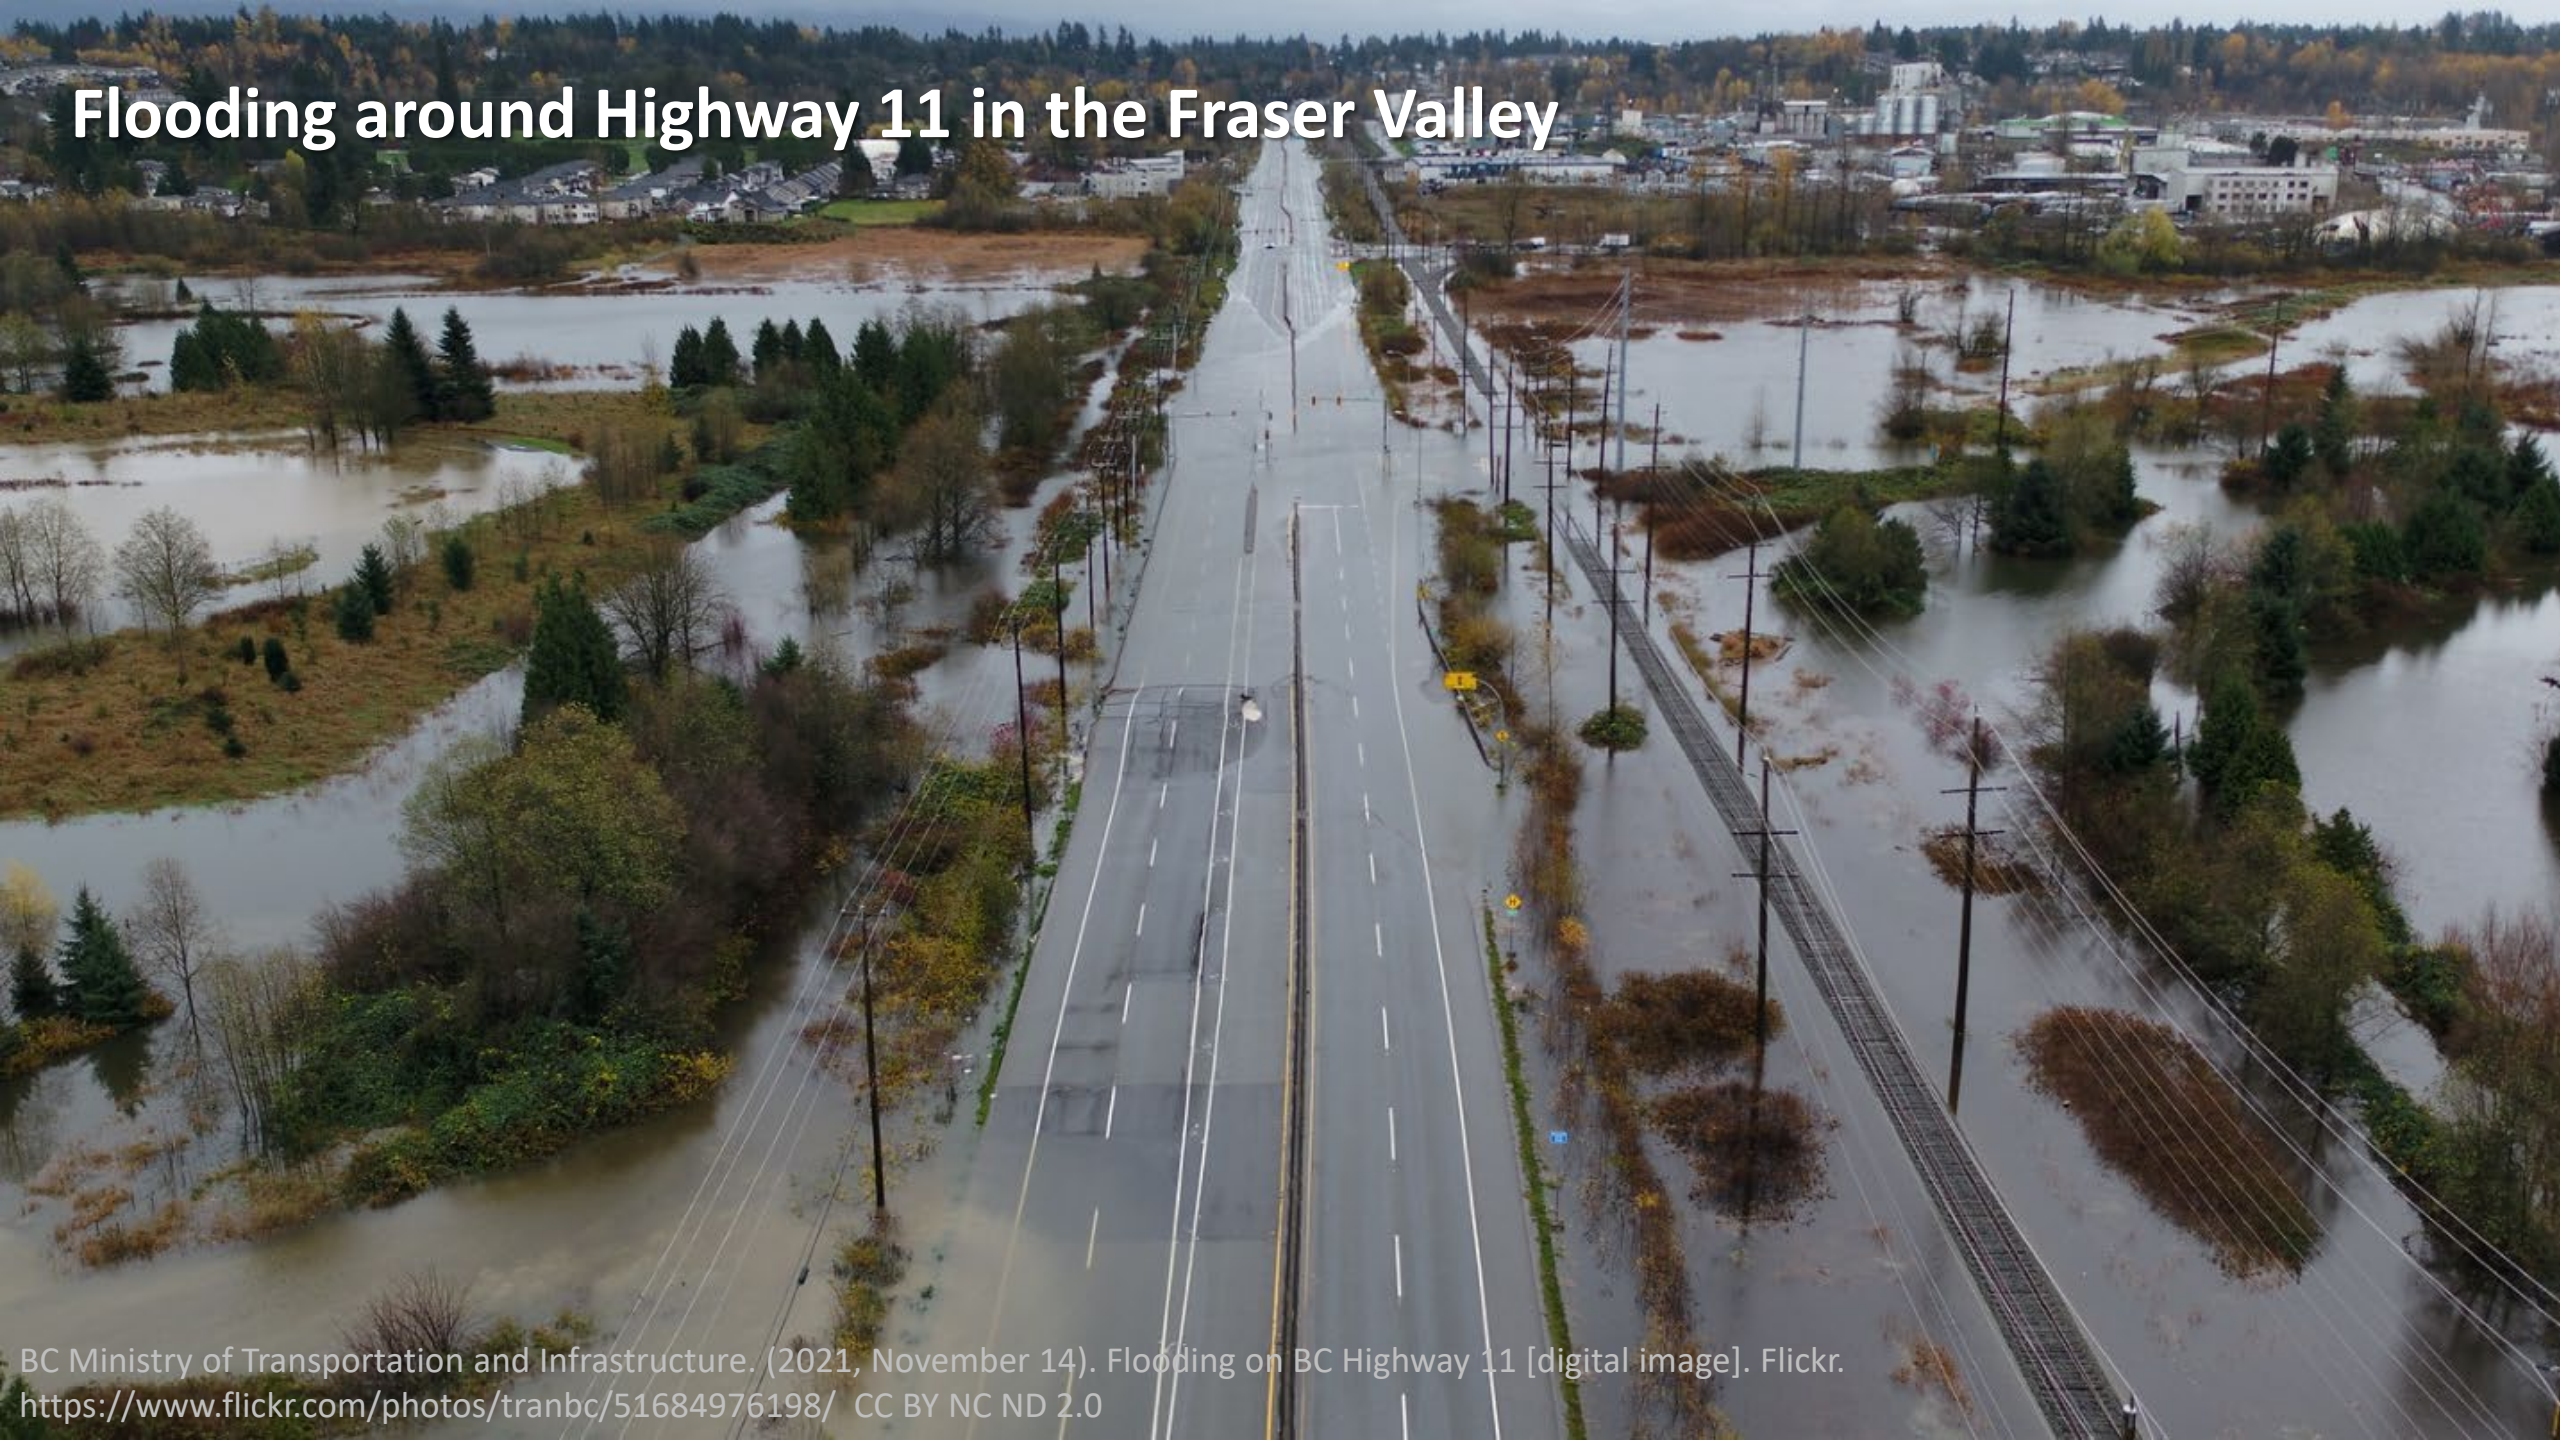
Flooding around Highway 11 in the Fraser Valley

Flooding around Highway 1 in the Fraser Valley

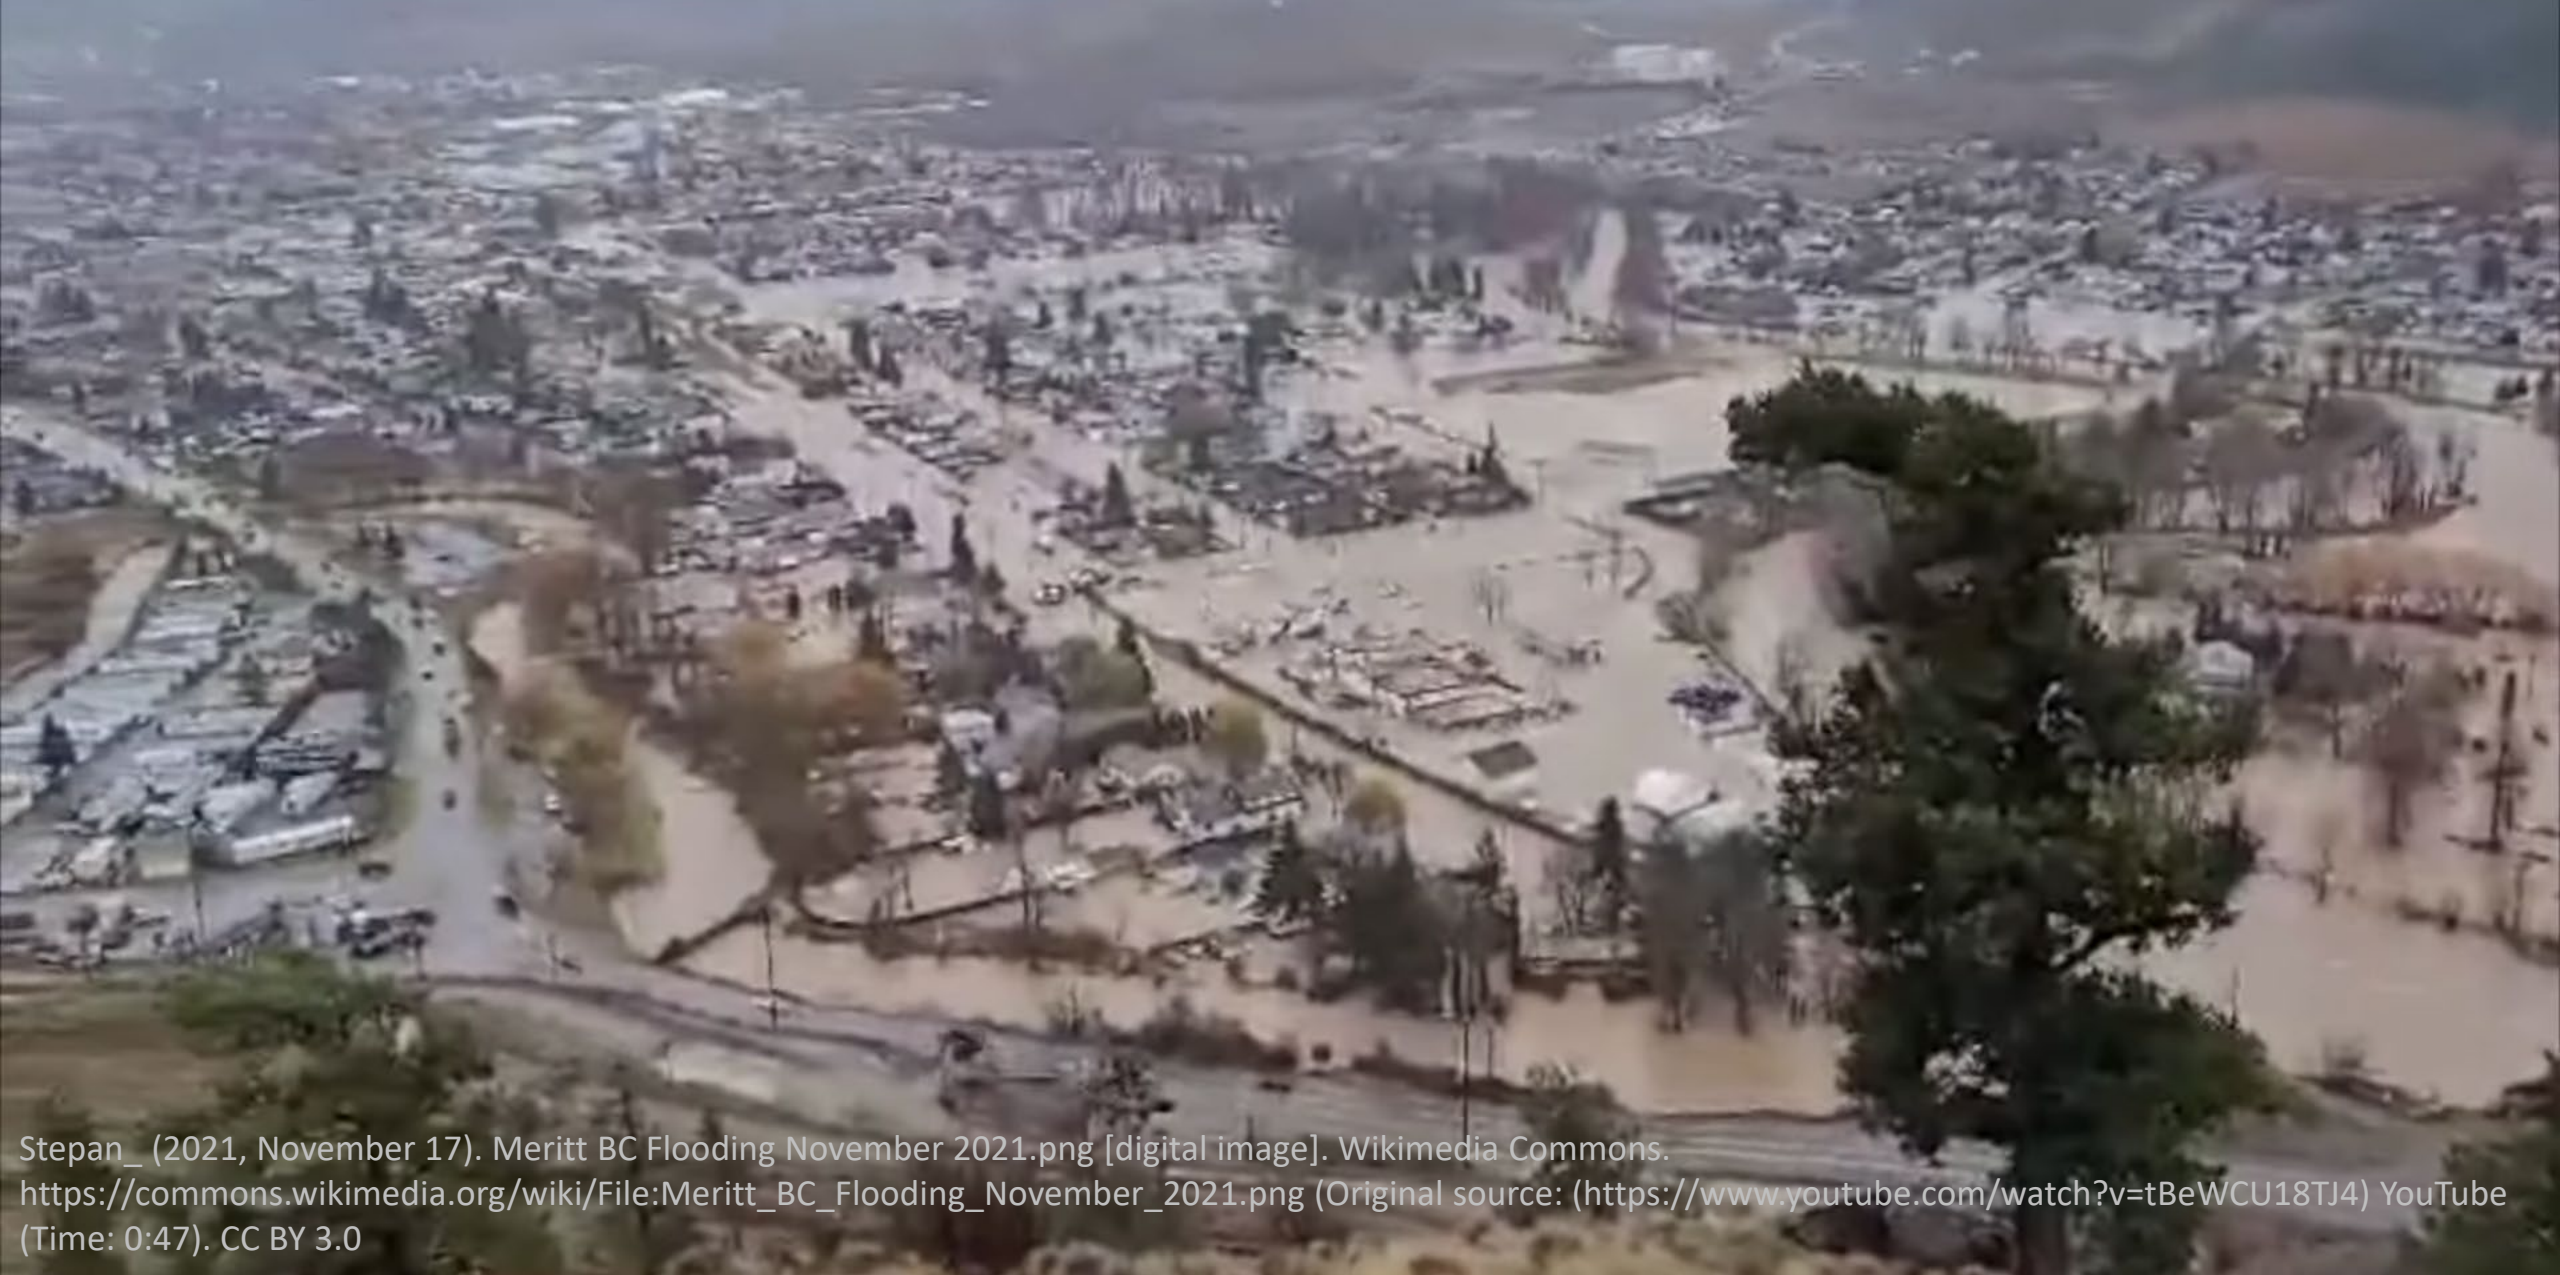
Flooding in Merritt in the BC interior

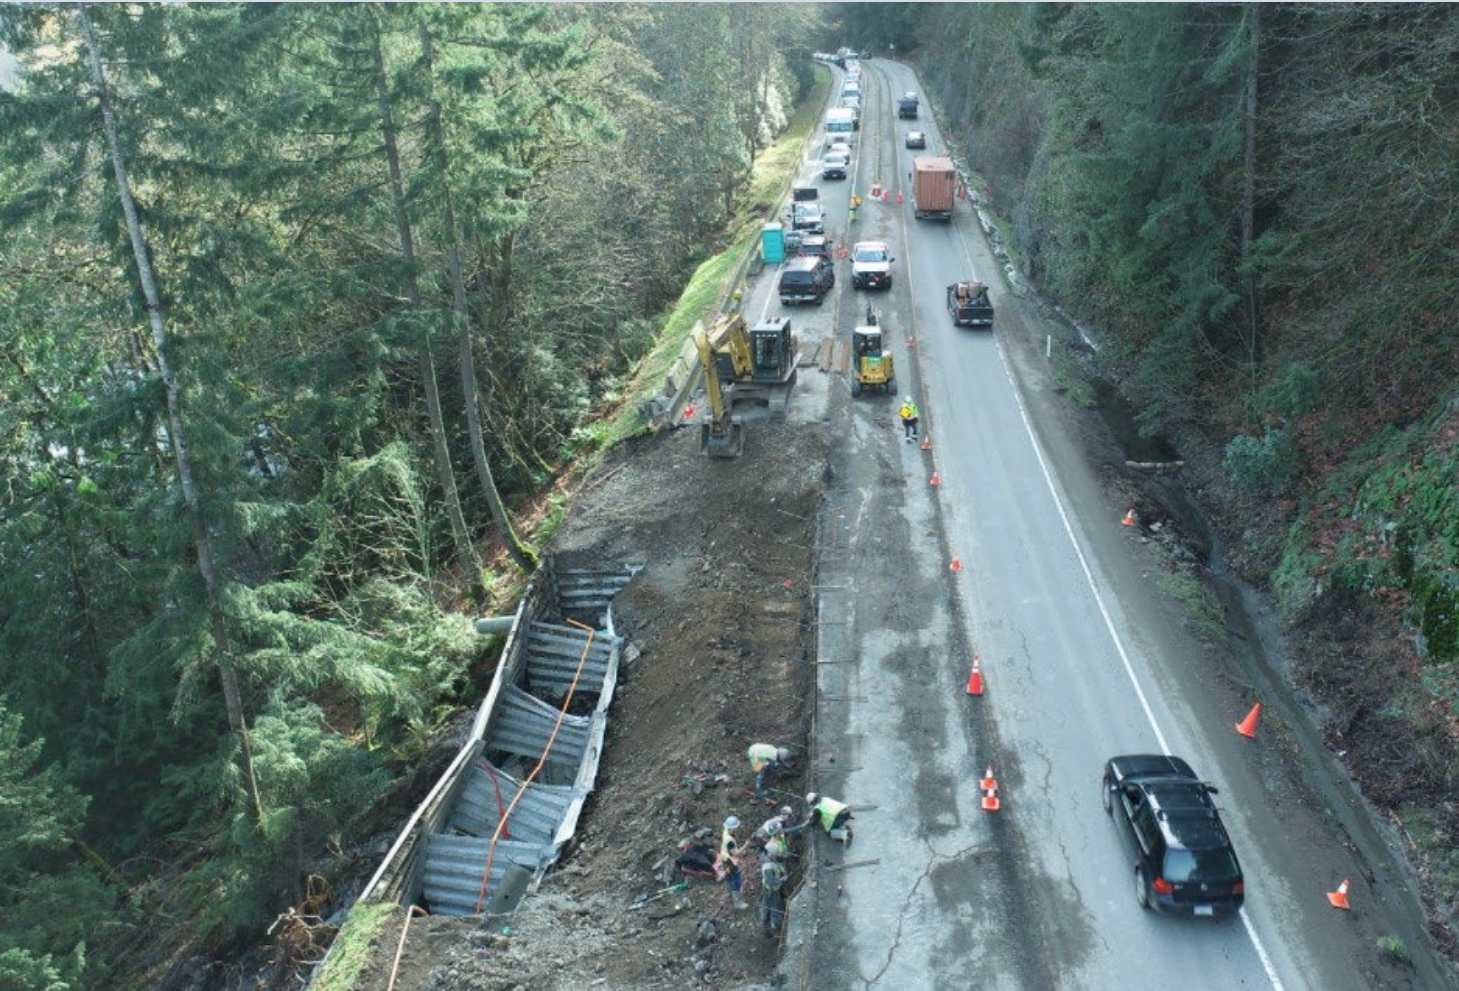
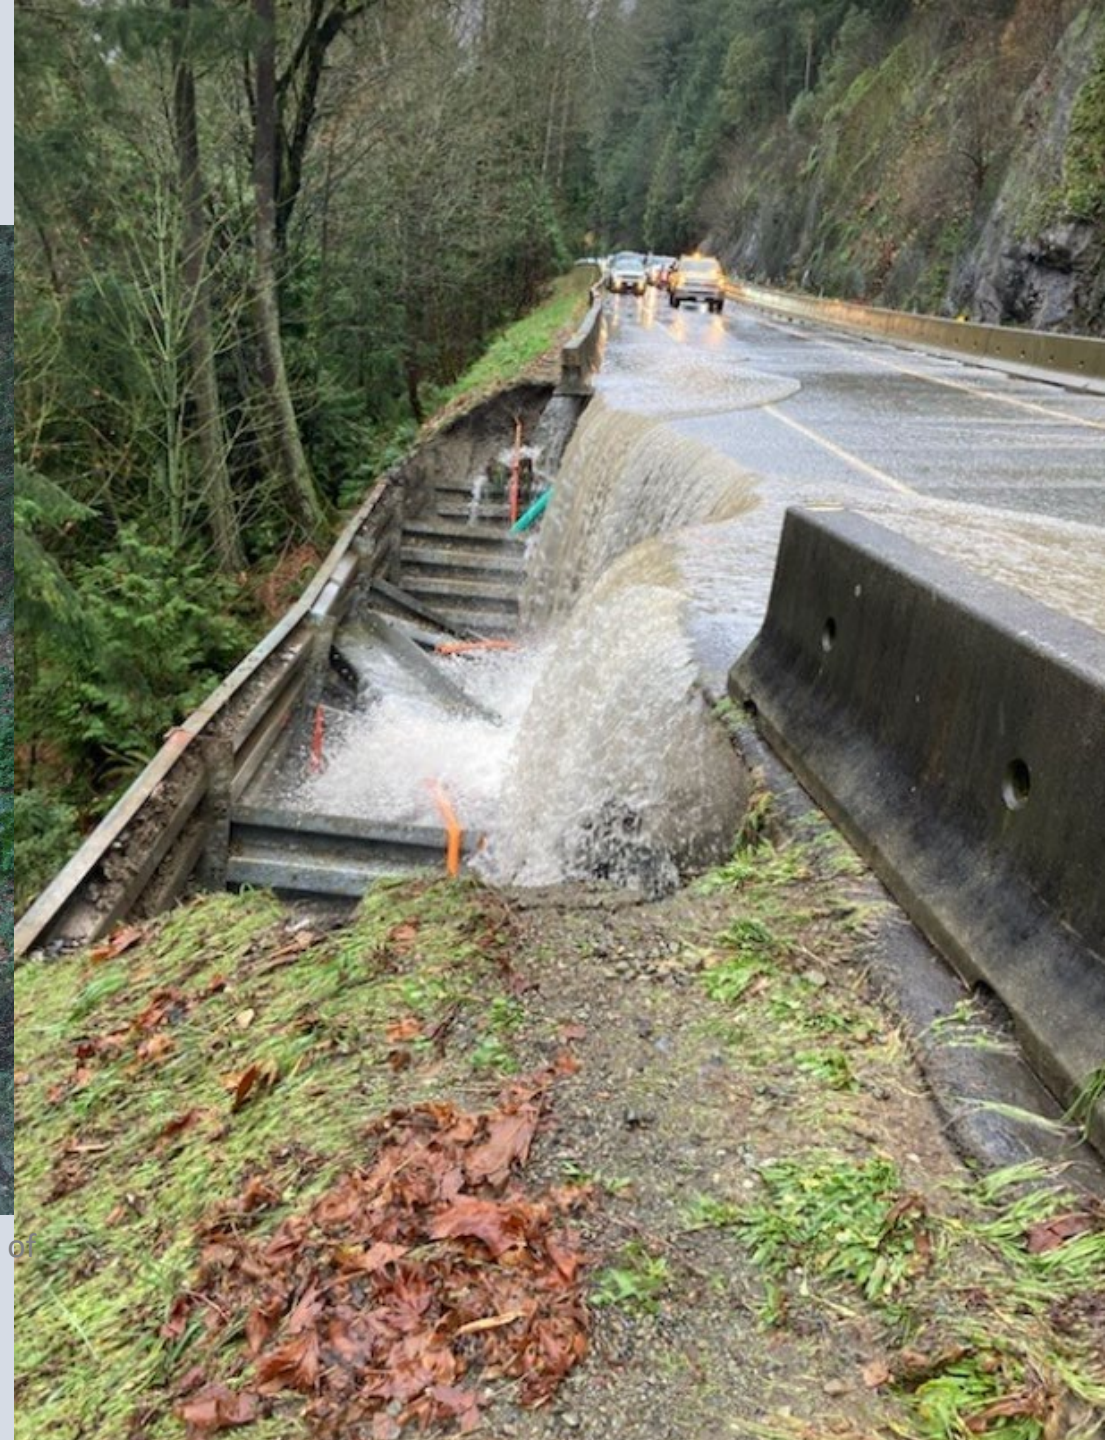
River flooding led to road damage in many areas because highways were not designed to withstand rainfalls of this magnitude.

Flood damage on Highway 19 on Vancouver Island

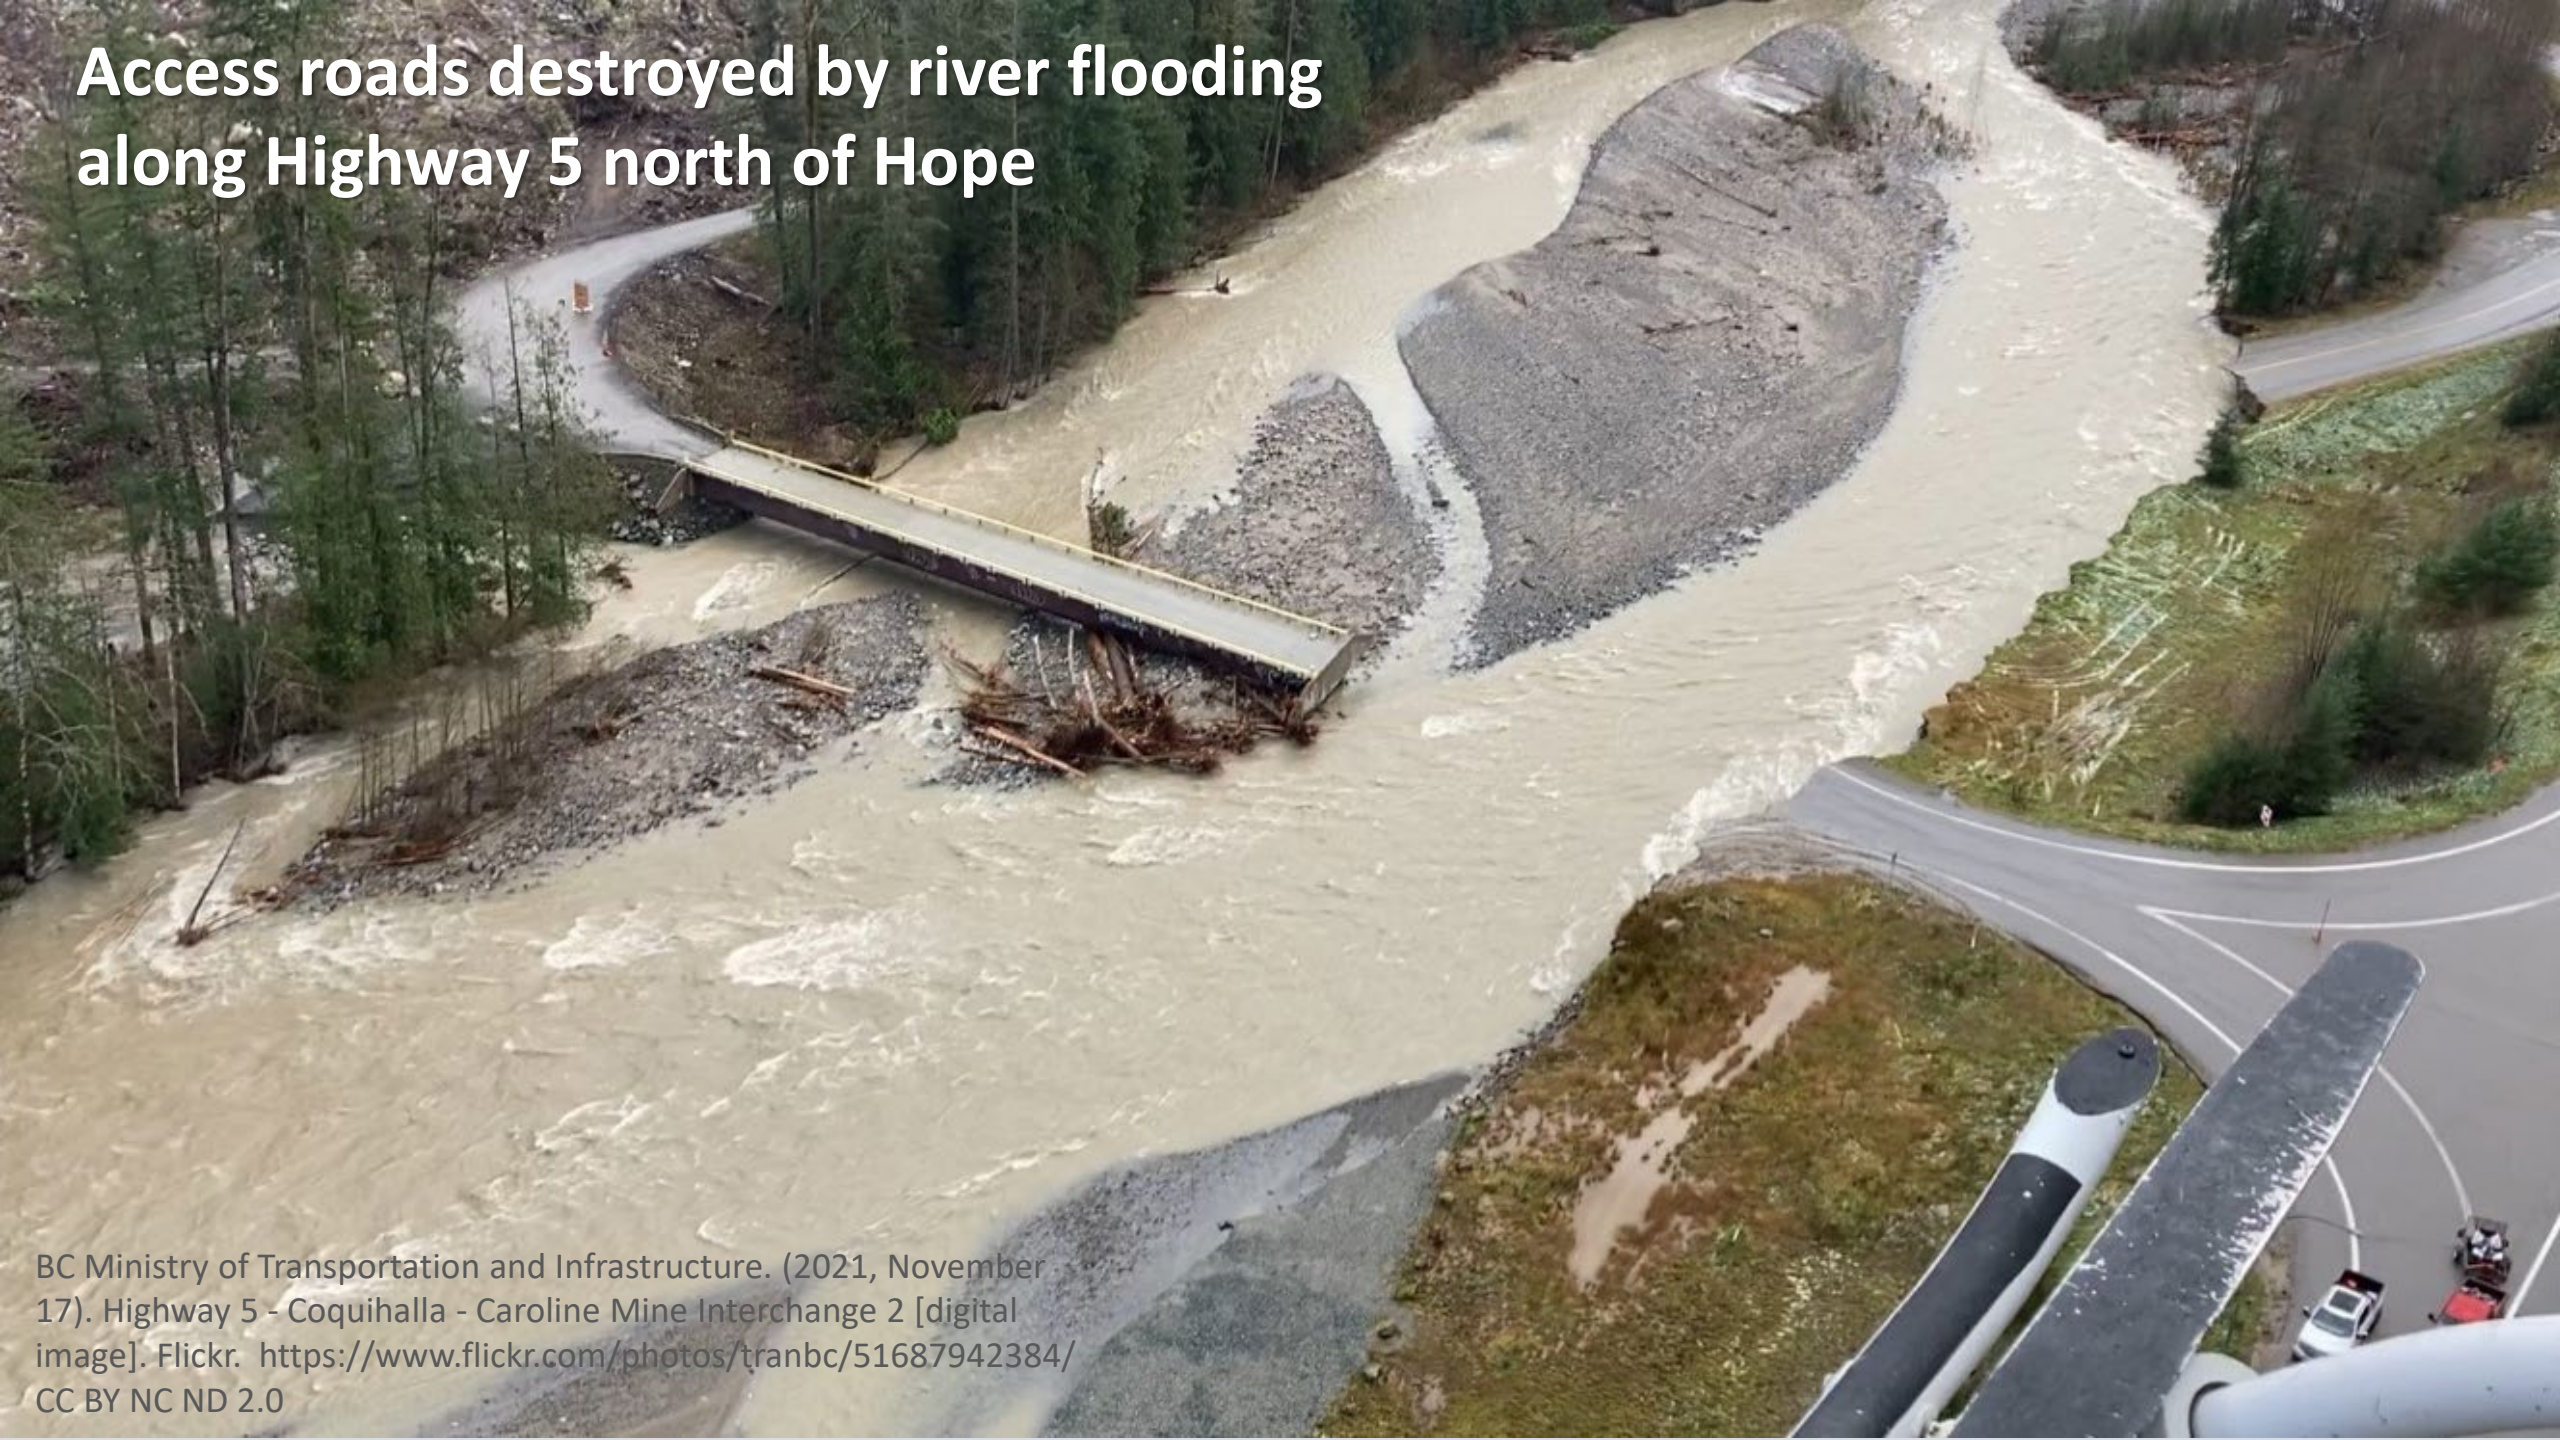
Access roads destroyed by river flooding along Highway 5 north of Hope

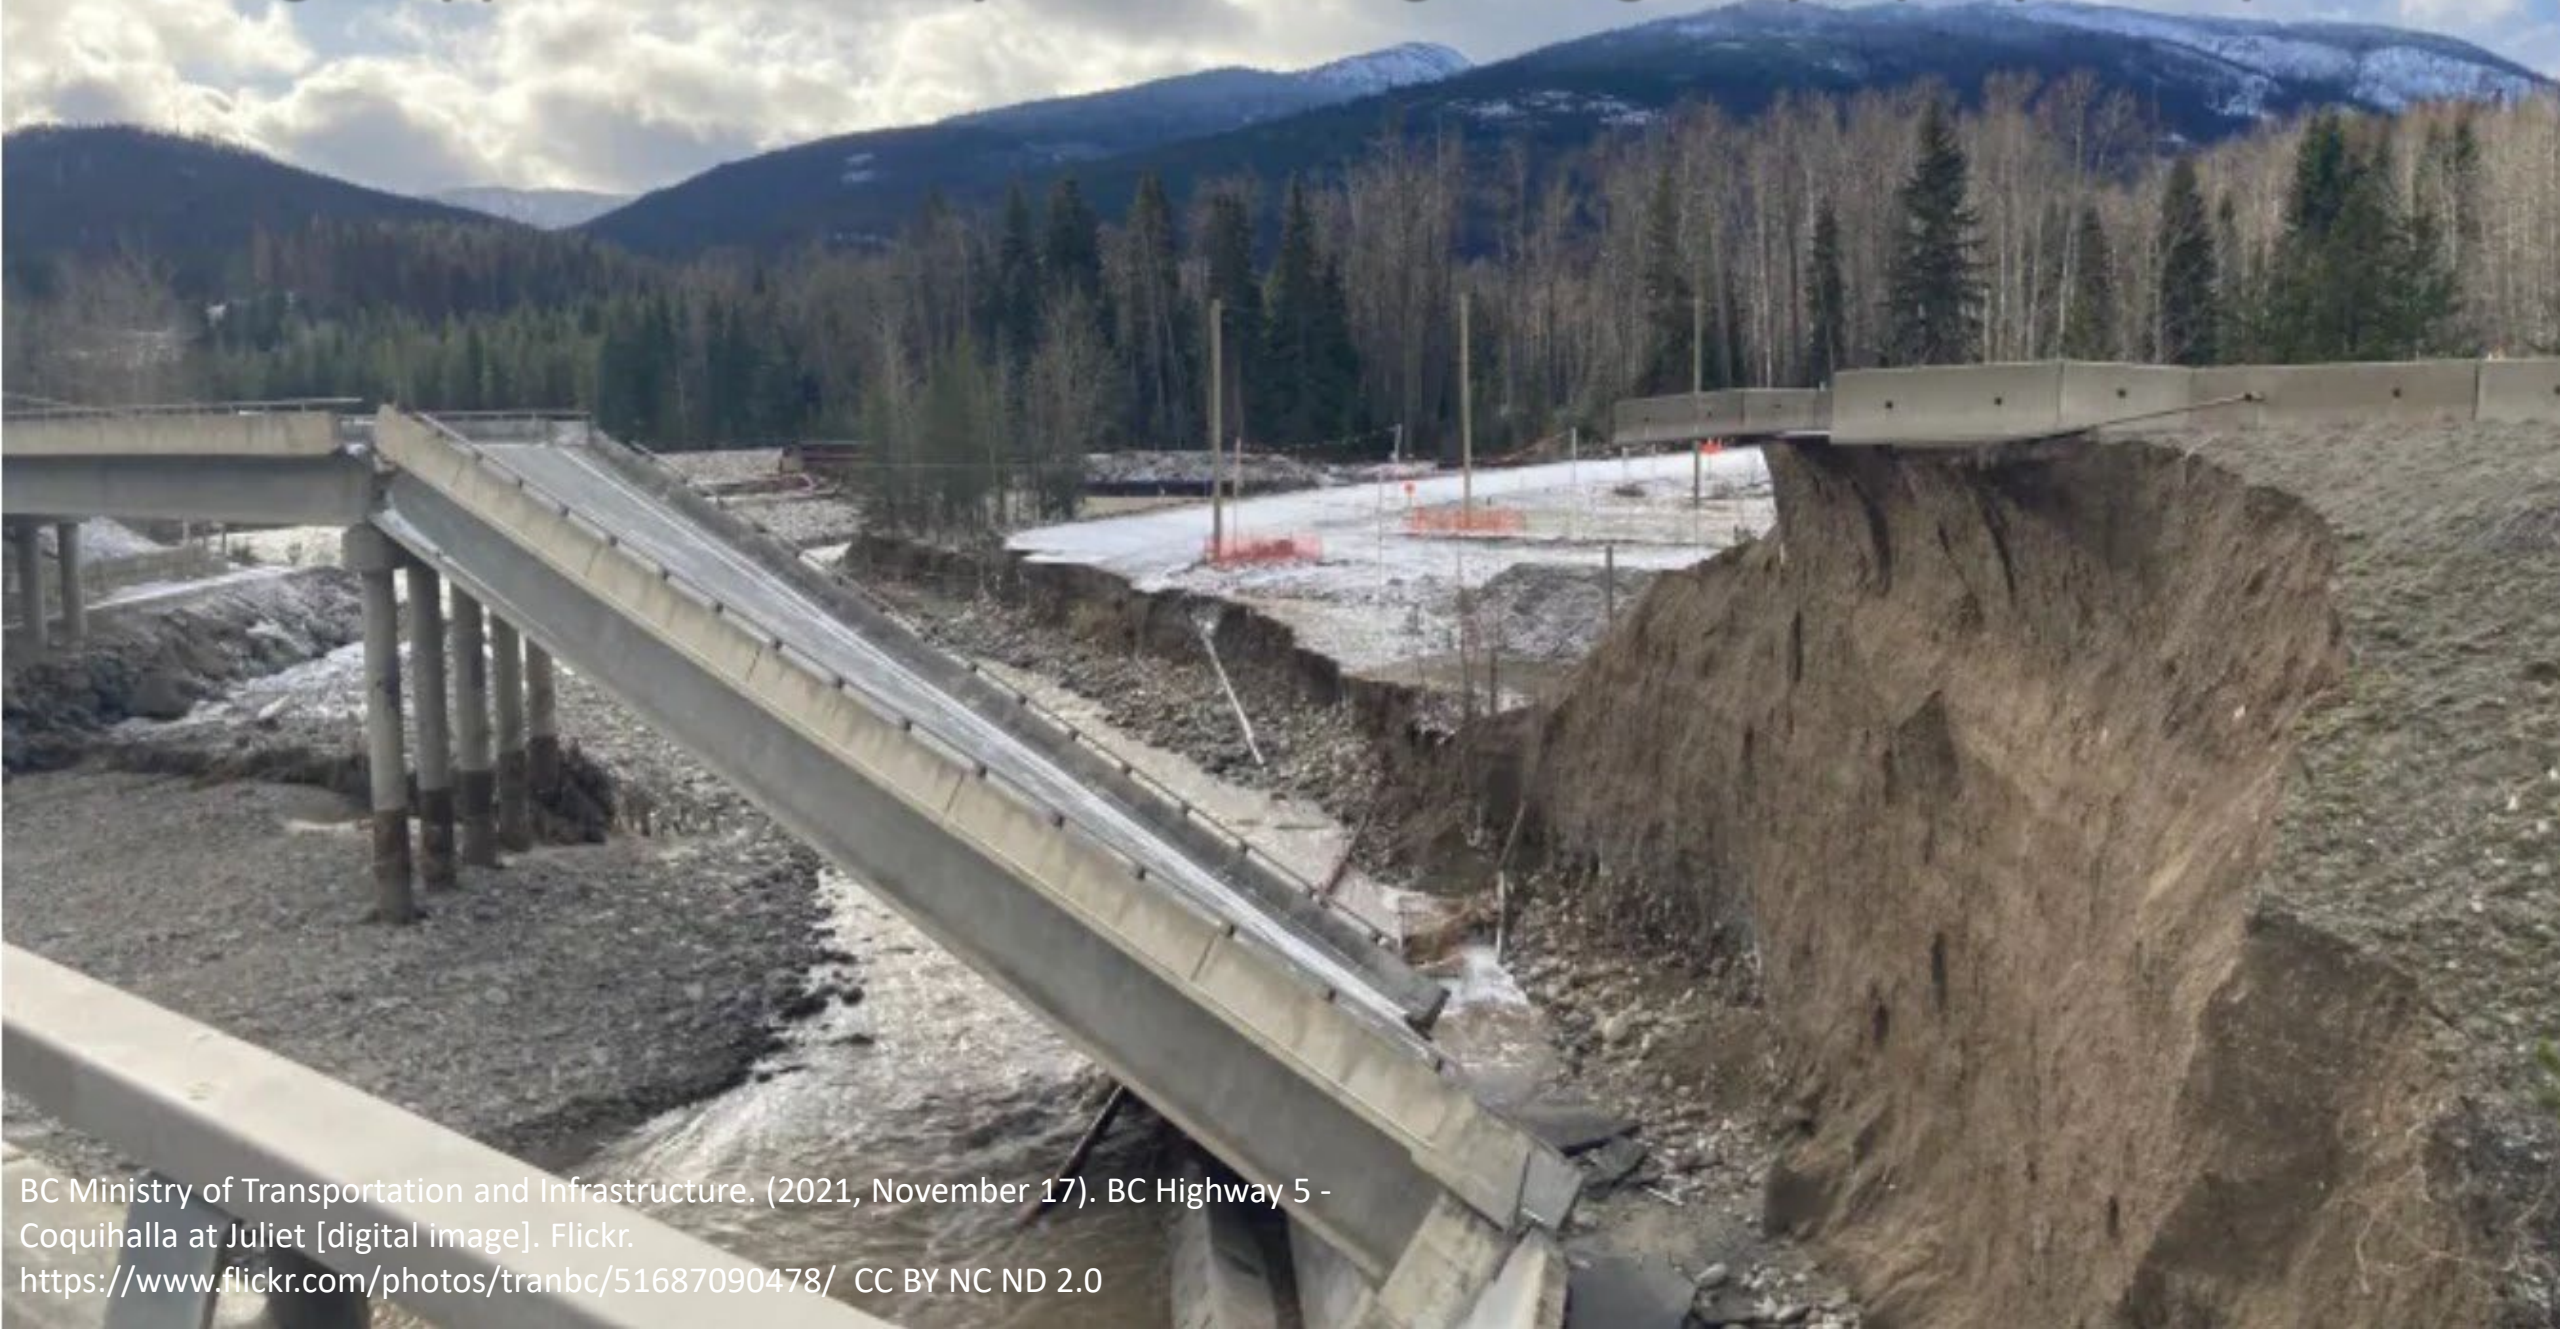
A bridge support undercut by river flooding on Highway 5 (Coquihalla)

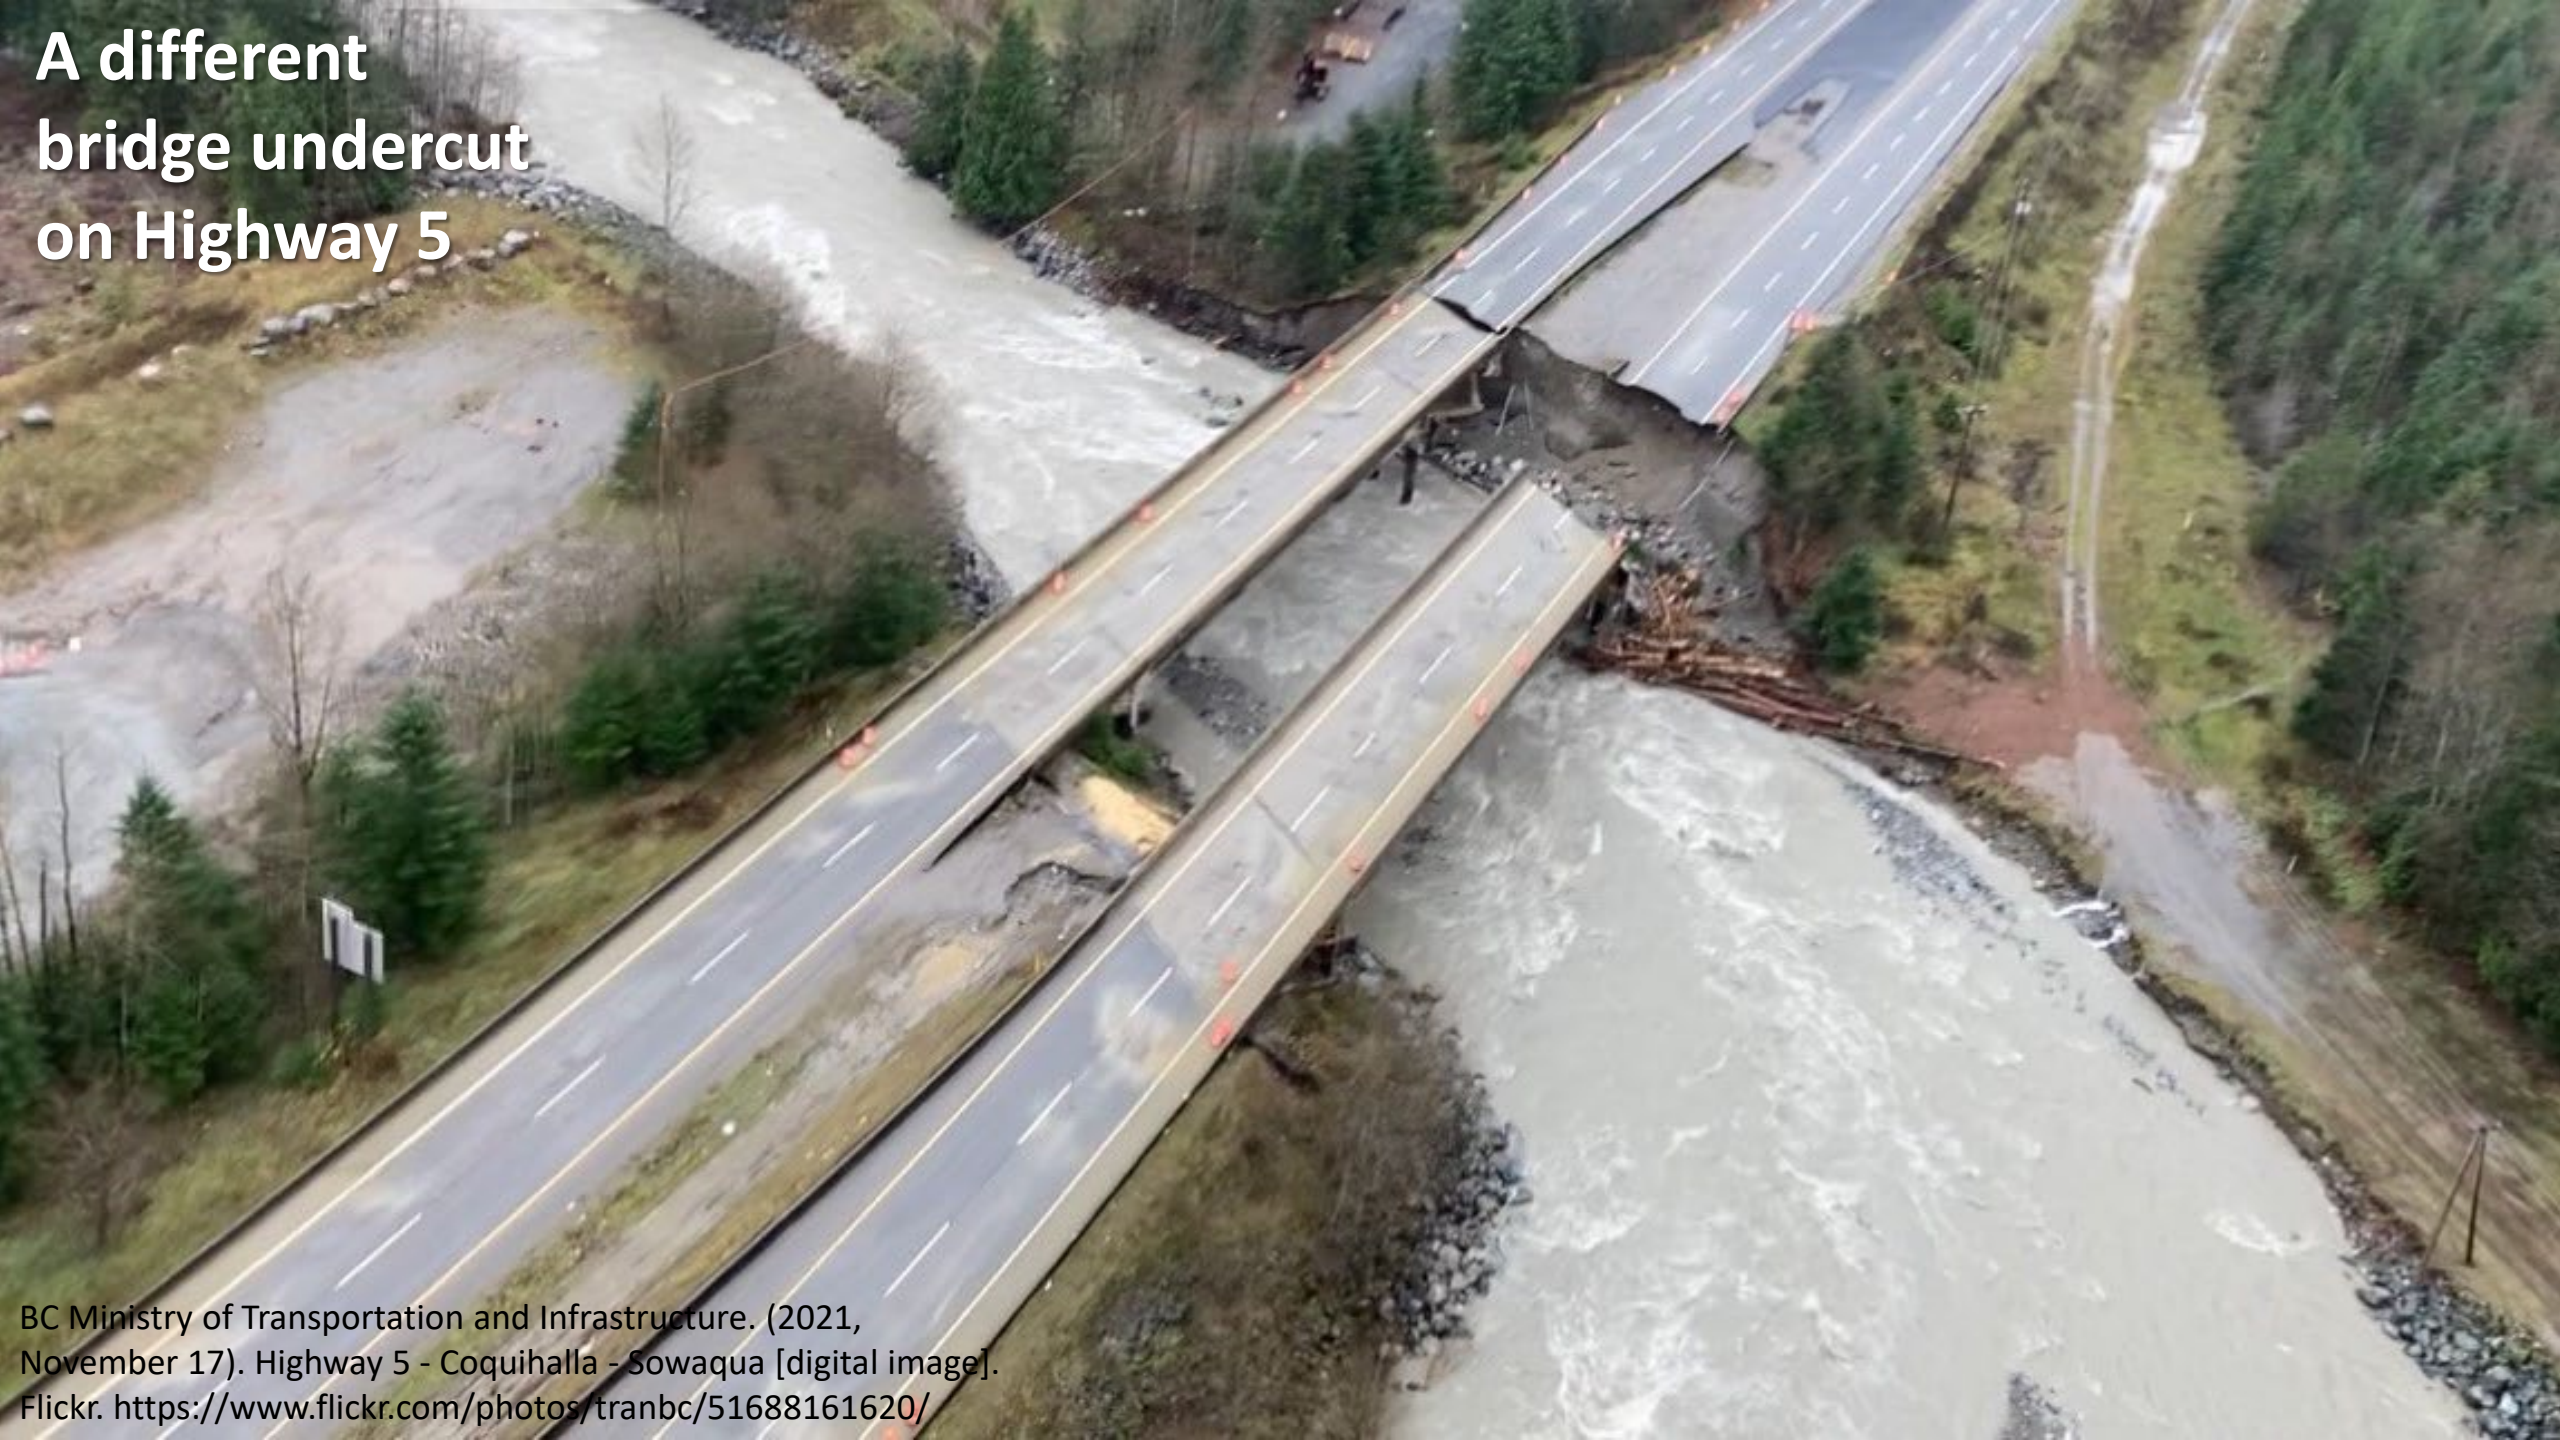
A different bridge undercut on Highway 5
