Atmospheric River: Rain, Flooding and Slope Failures

British Columbia and Washington, November 2021

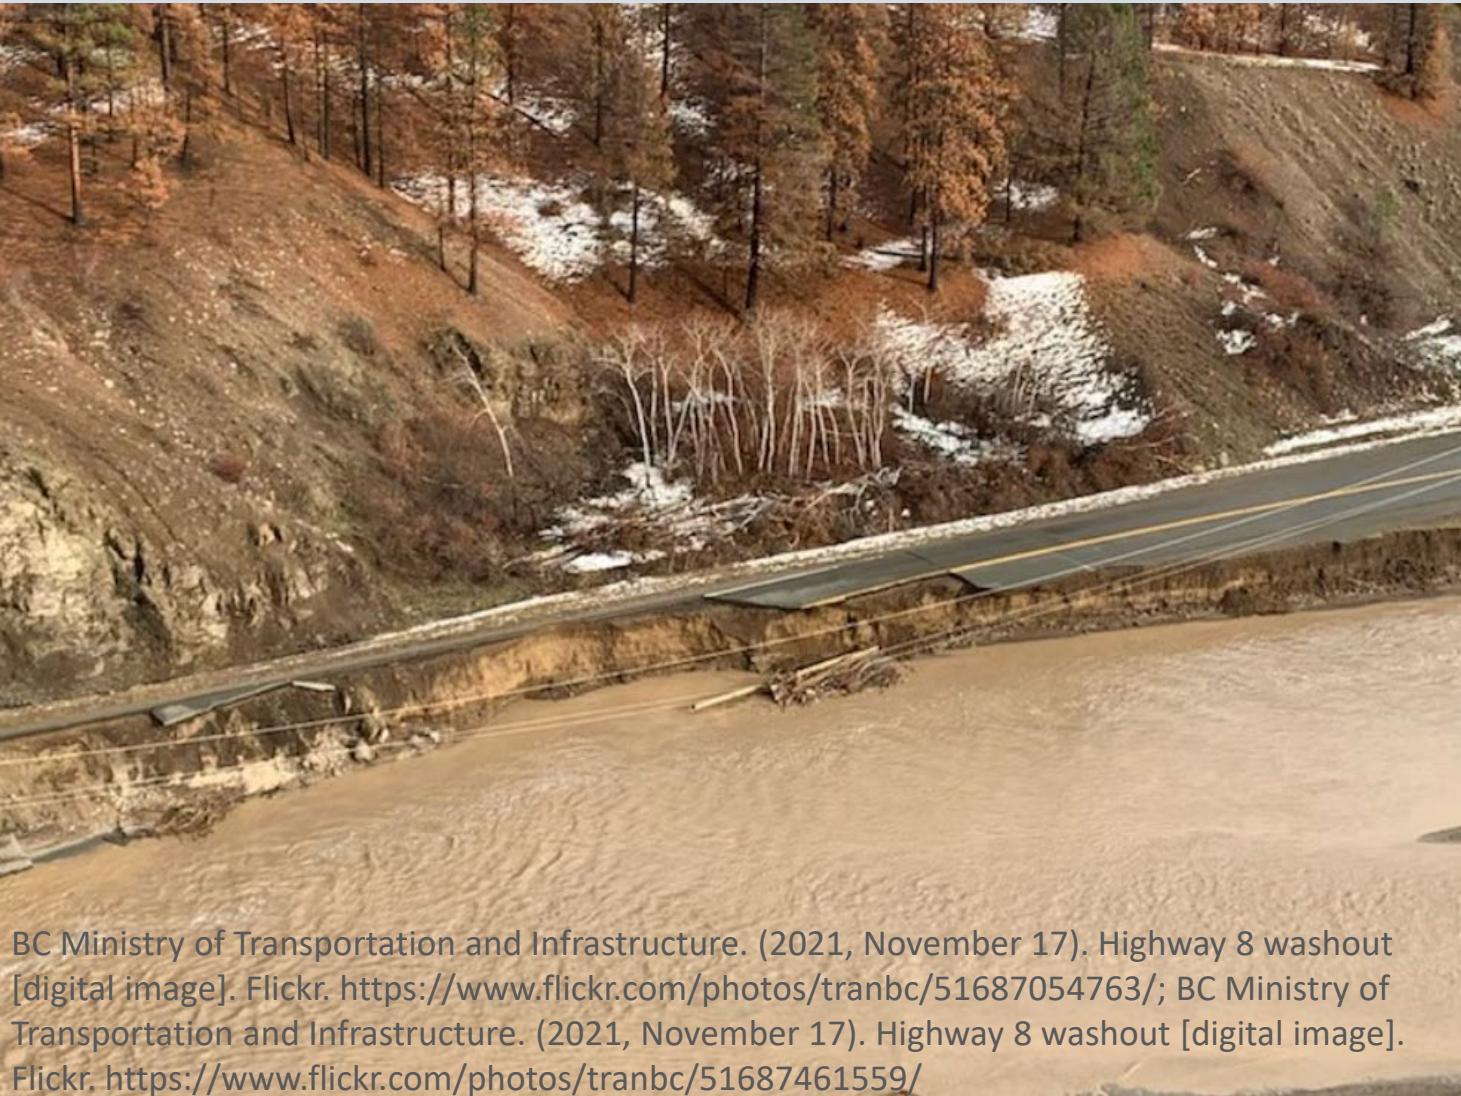
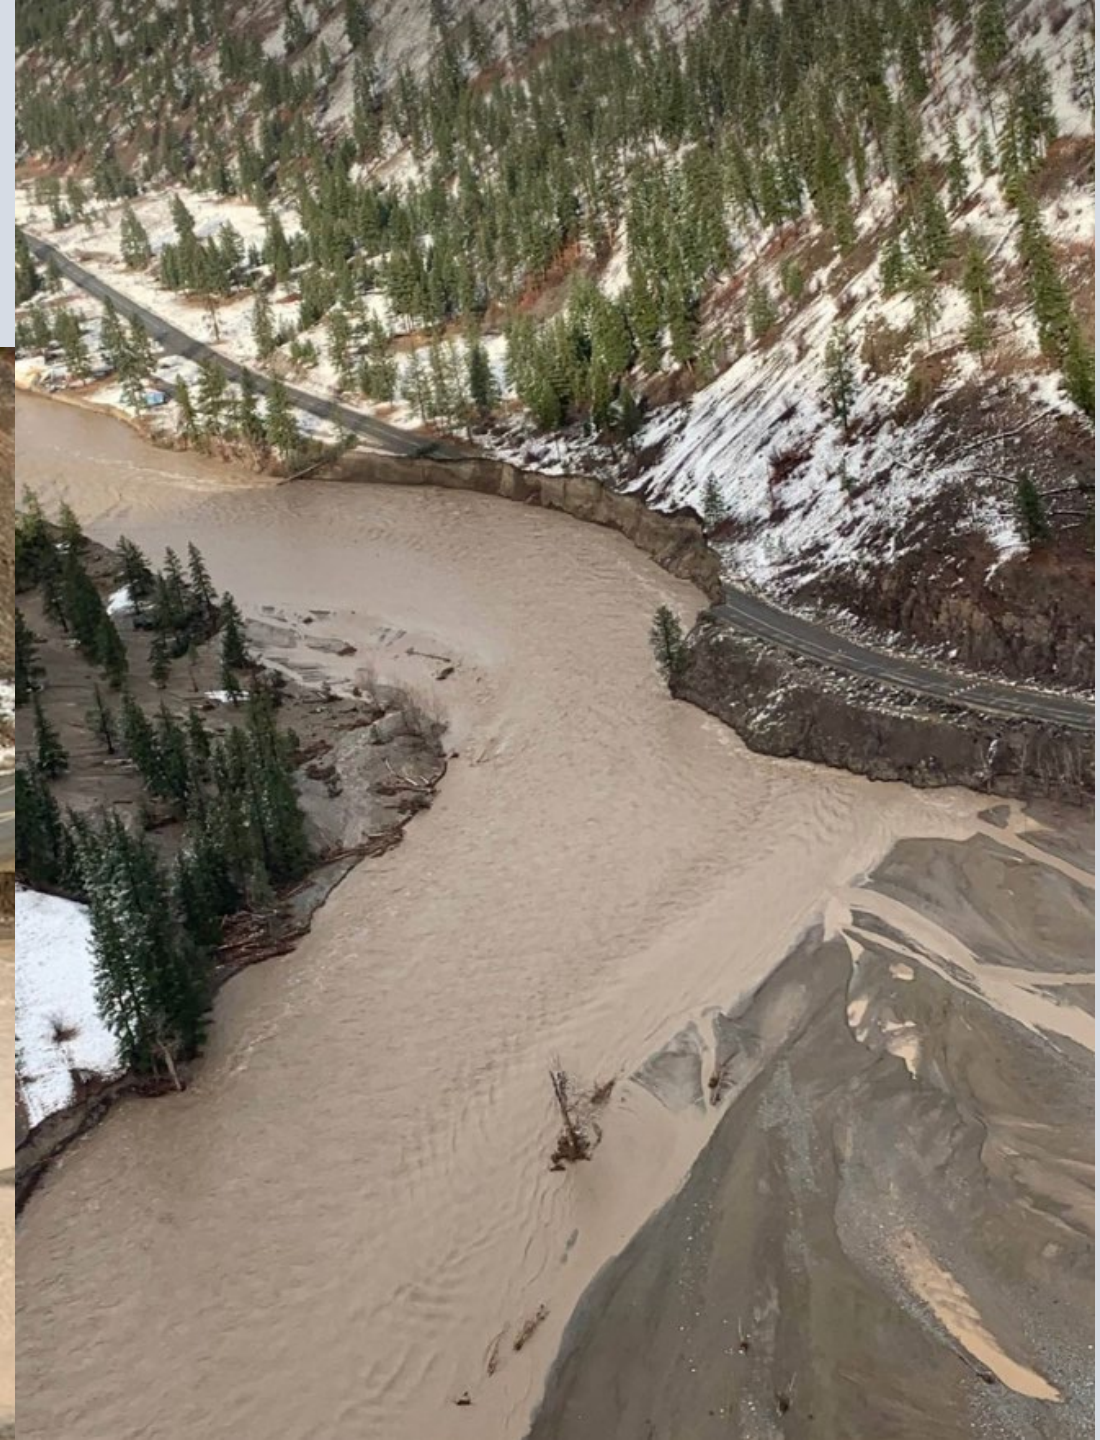
Roads destroyed by flooding along Highway 9 west of Merritt

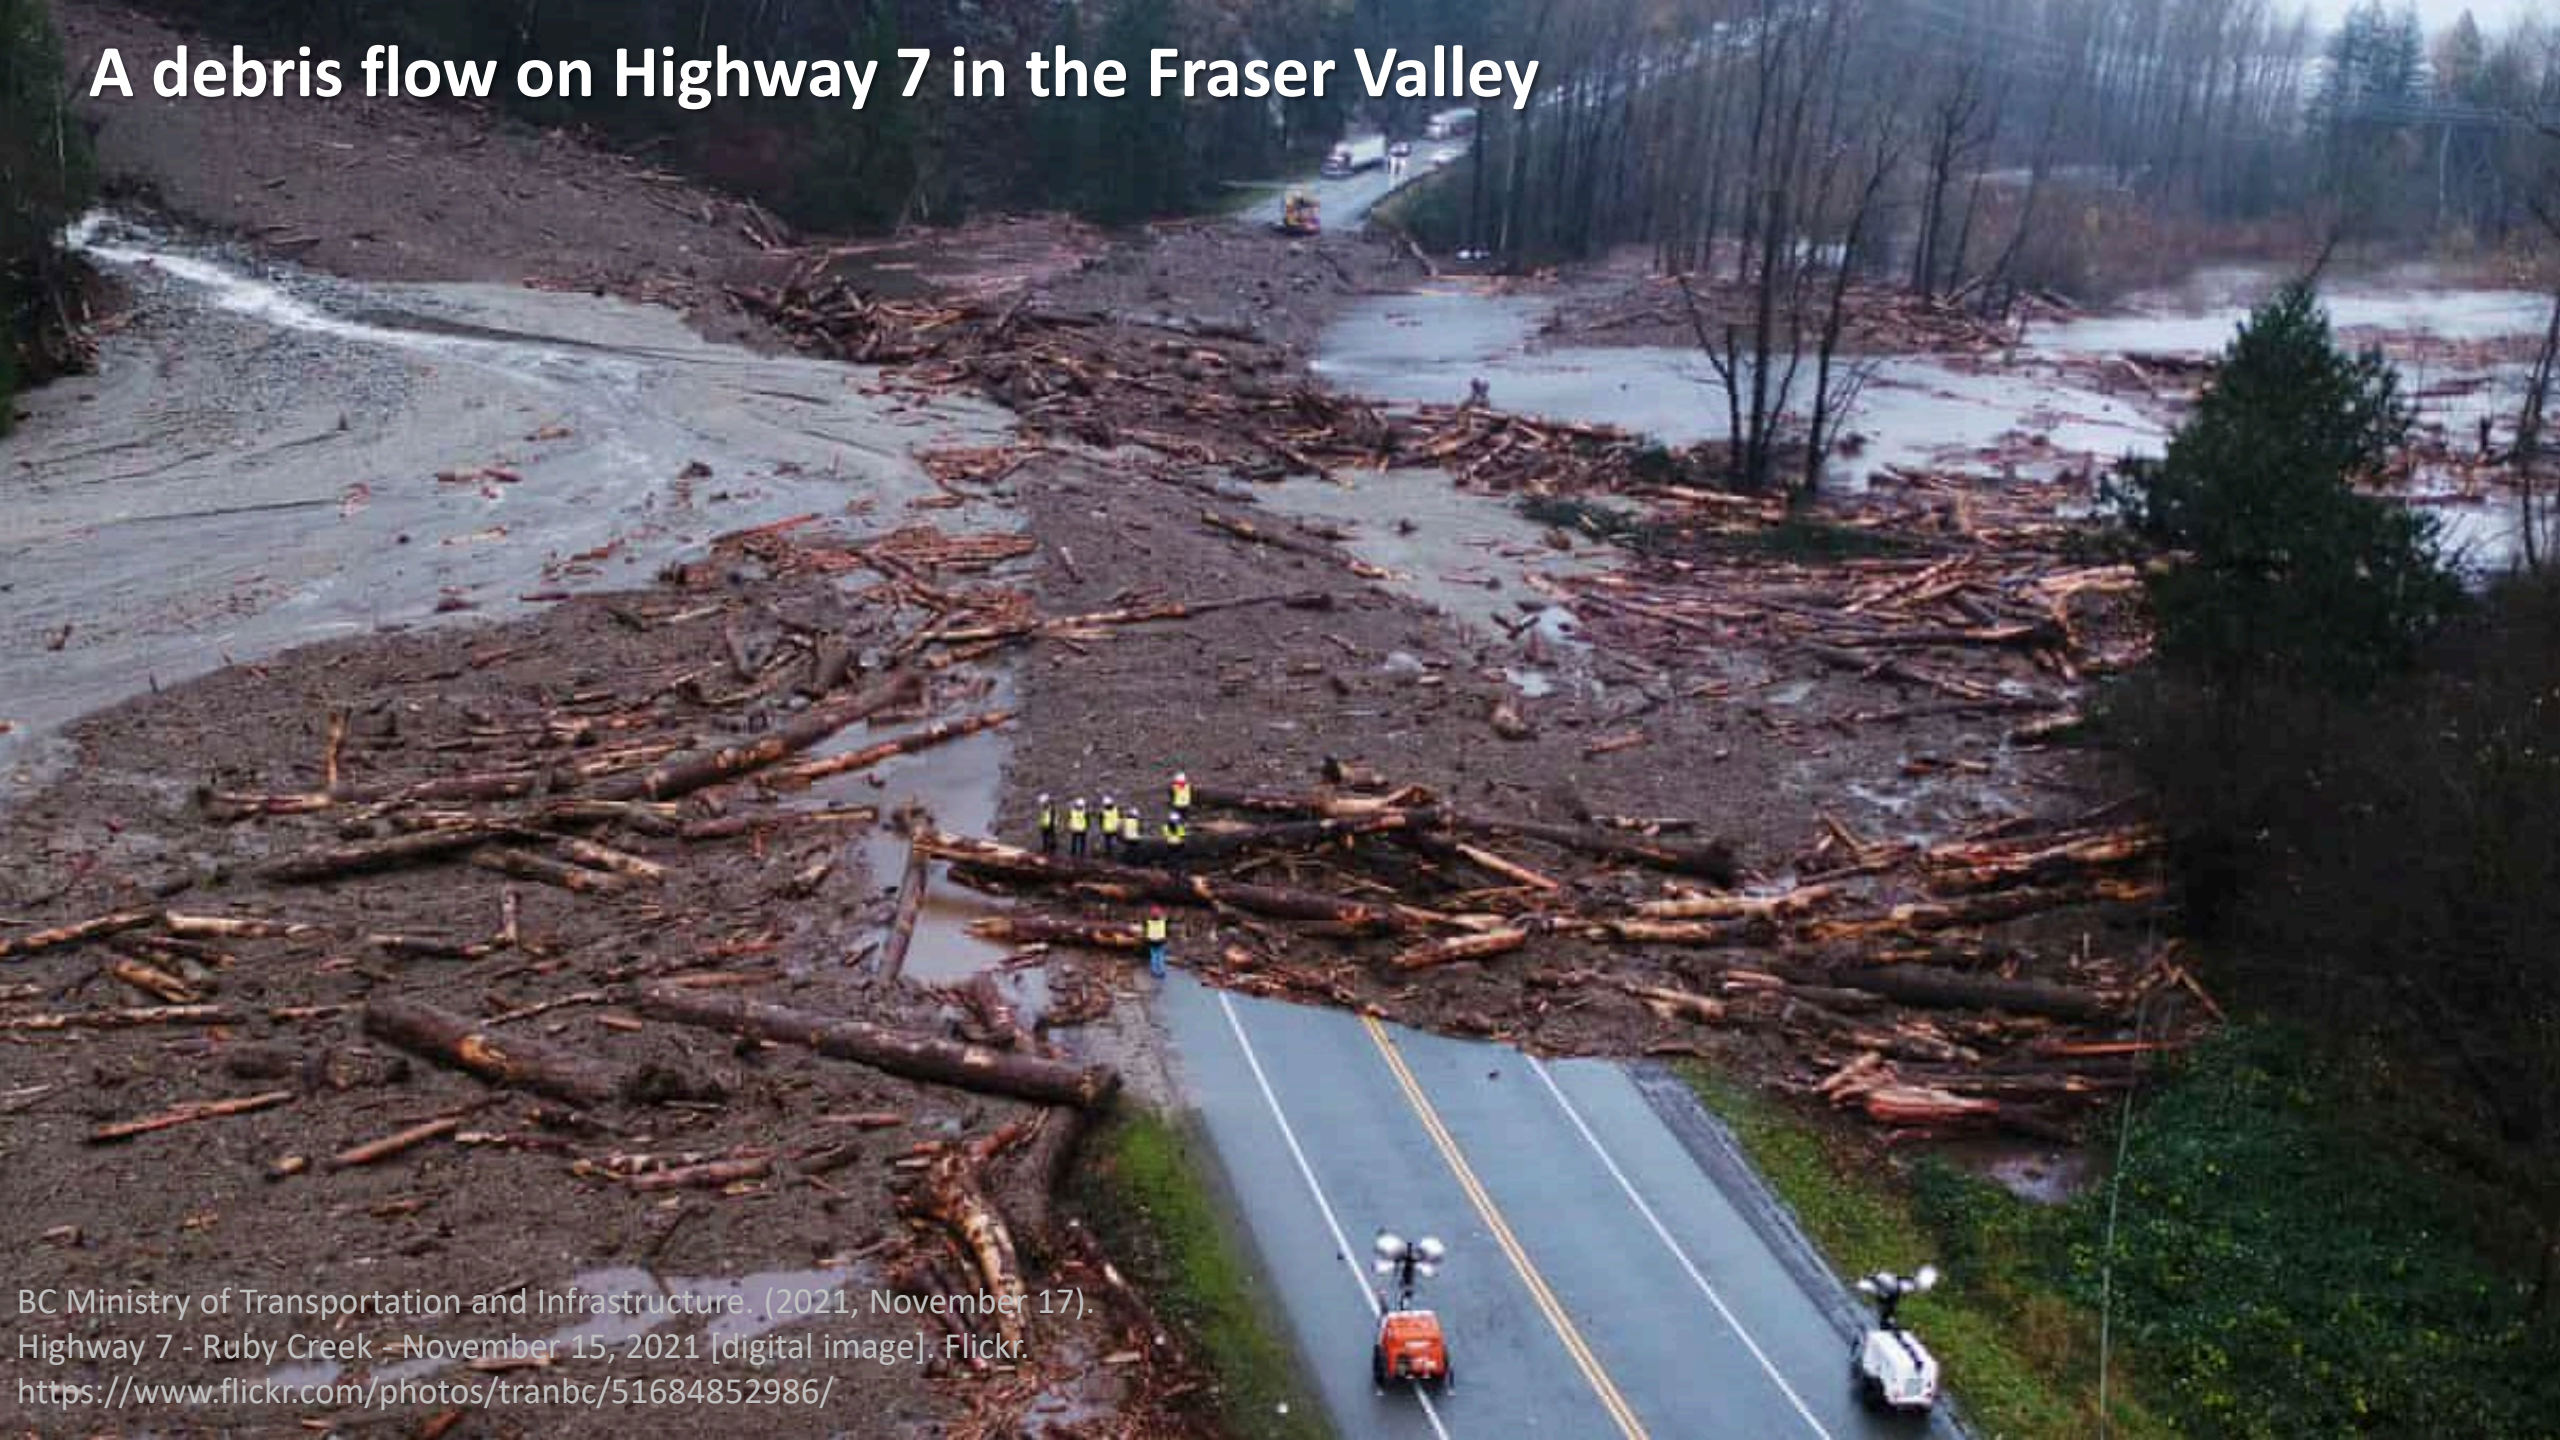
The heavy rain and the consequent melting of snow destabilized slopes in many mountainous regions of southwestern BC. That led to debris flows on a scale that the existing highway infrastructure was not designed to withstand.

A debris flow on Highway 7 in the Fraser Valley

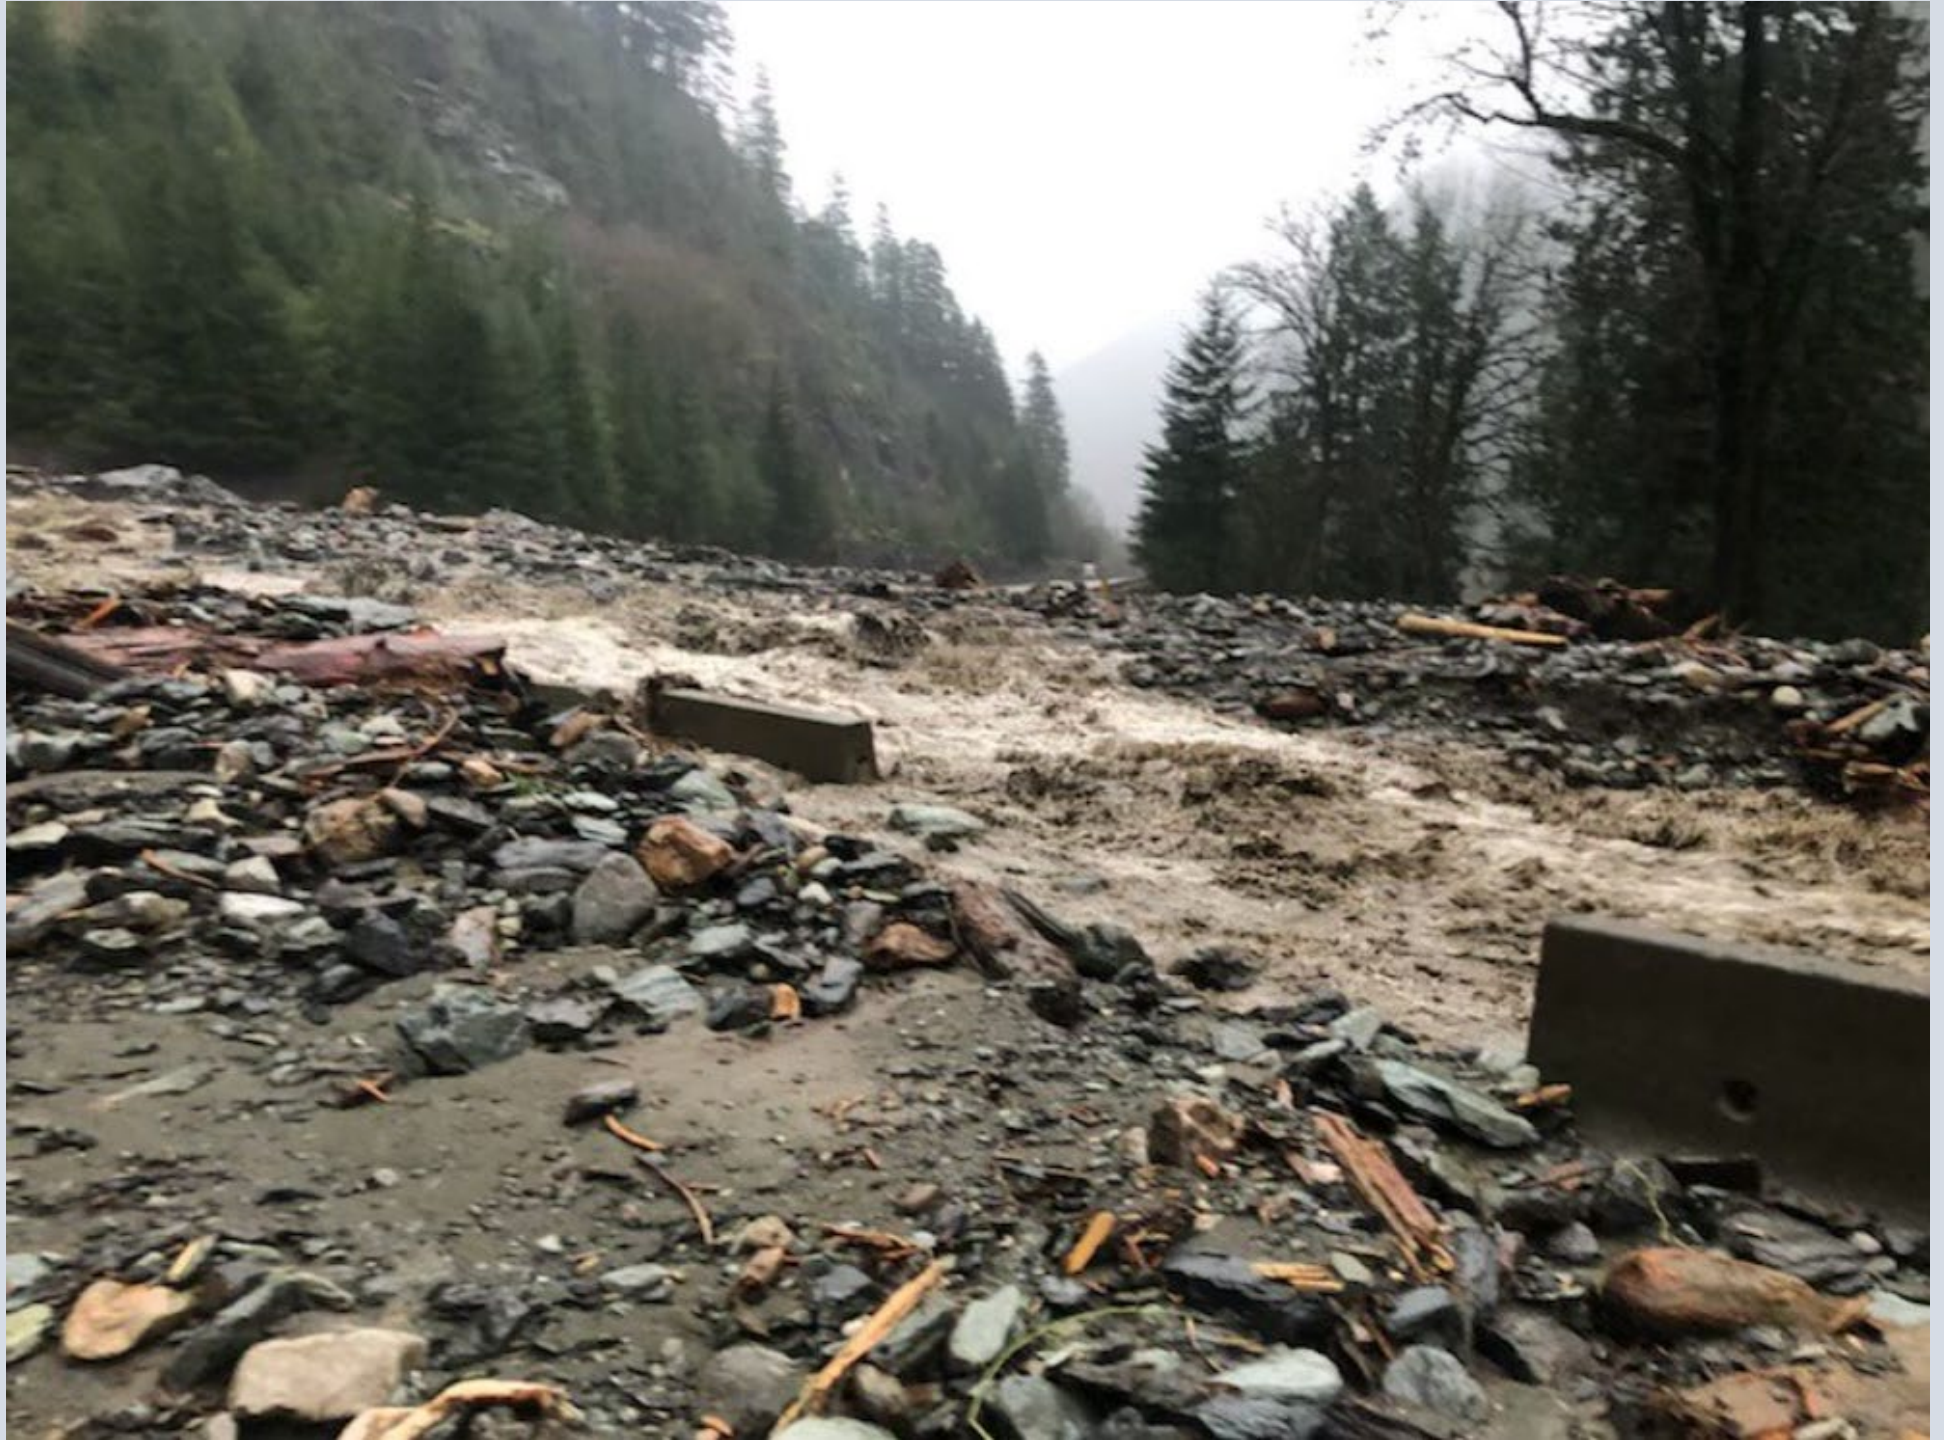
A debris flow on Highway 5 at Ten Mile Creek.

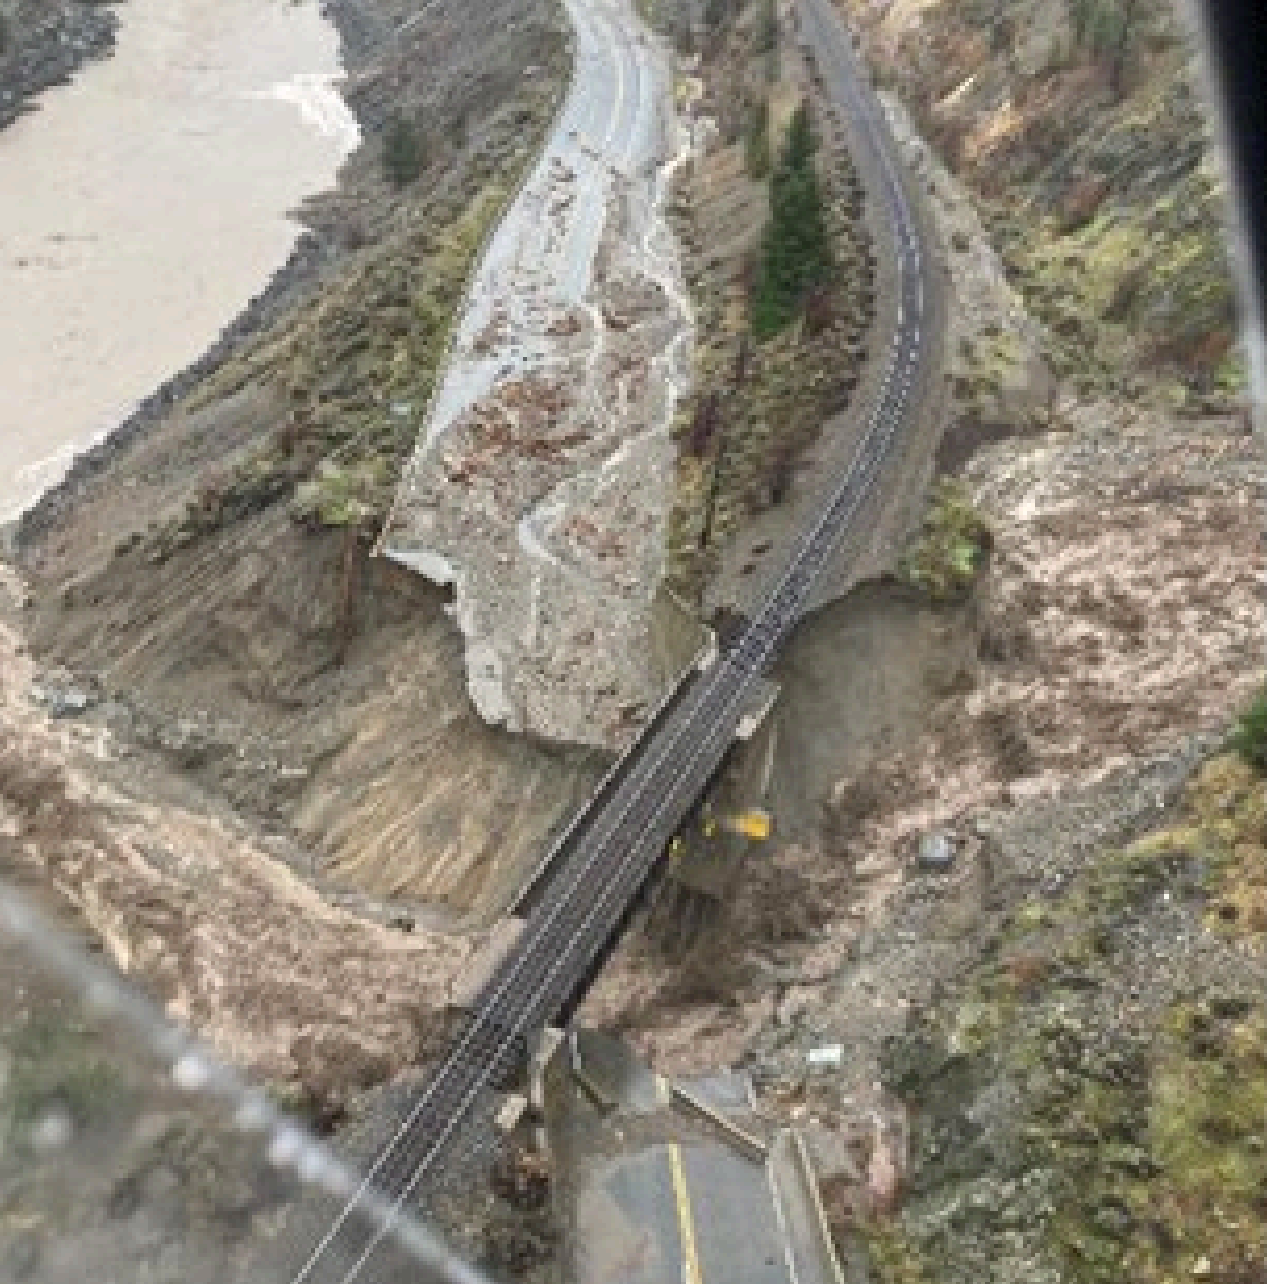
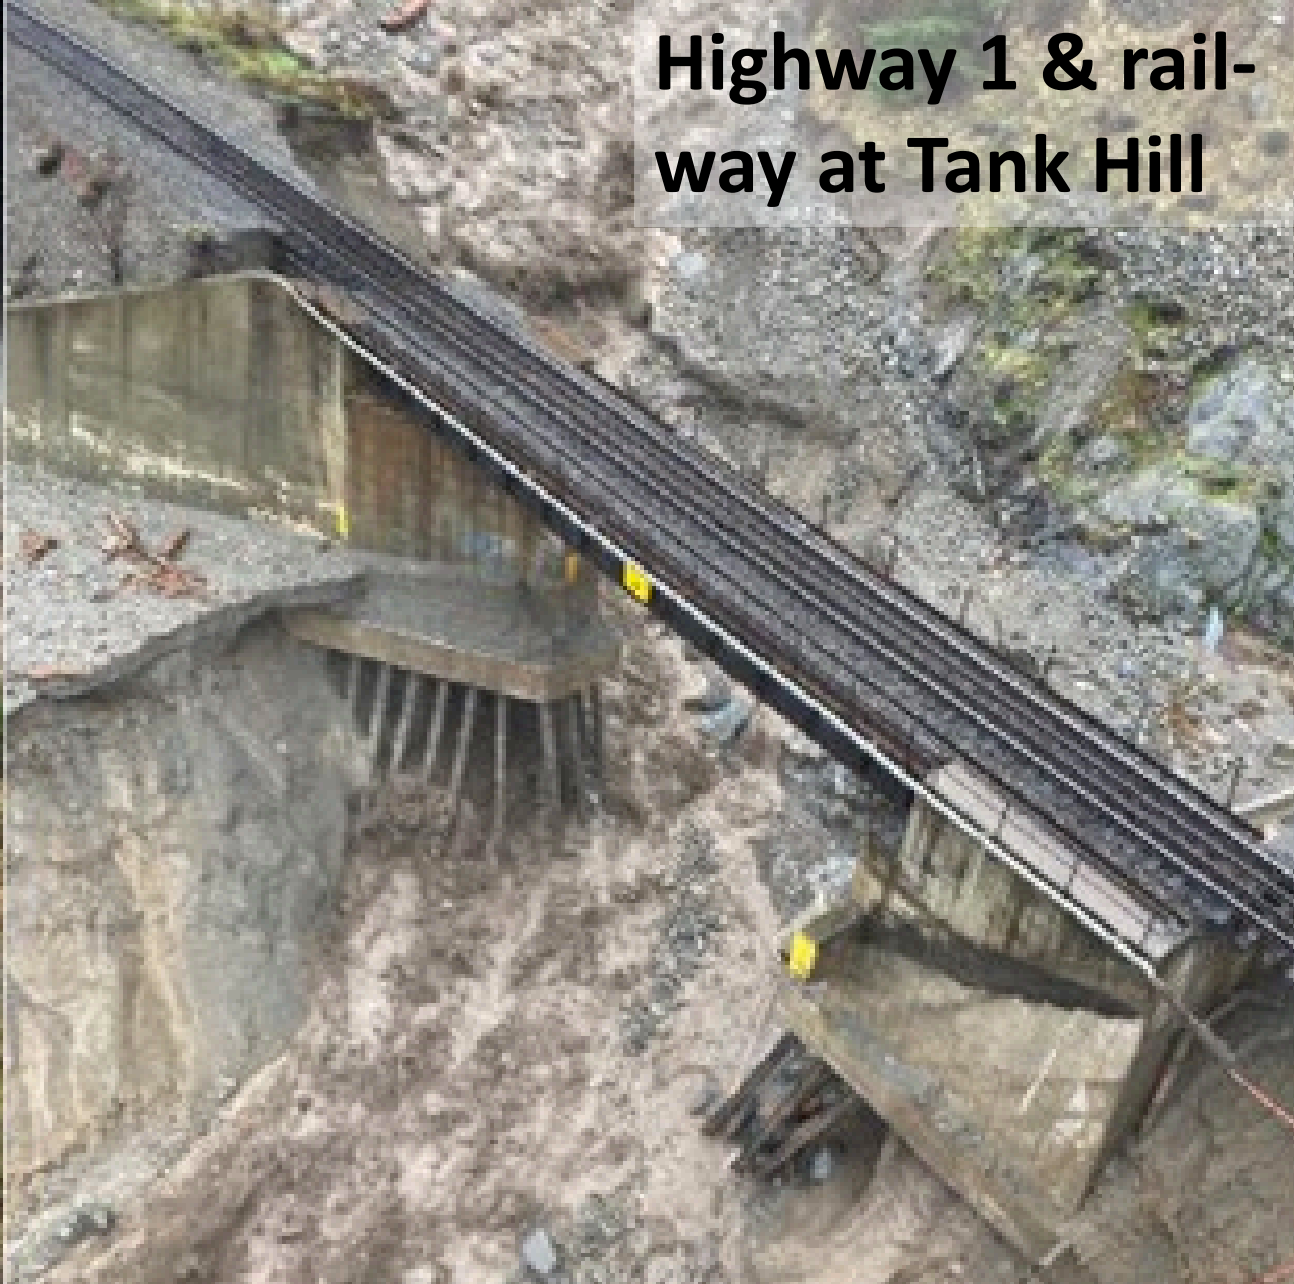
Highway 1 & railway at Tank Hill

An aerial photograph showing a massive debris flow of grey rocks and sediment that has completely destroyed a section of Highway 1 and the adjacent railway tracks. The debris flow is a wide, chaotic path of destruction cutting through the landscape. To the right, a river with muddy, brown water flows. In the center, several workers in orange safety gear are visible near the wreckage of the infrastructure. The surrounding terrain is rugged and mountainous.

**Road and rail
infrastructure
destroyed by a
debris flow on
Highway 1 at
Tank Hill**
